Technical Inspection Report
Bureau of Ordnance Group

6
OPERATION CROSSROADS.

TESTS 'A' AND 'B'.
VOLUME IV.
PART X. PHOTOGRAPHIC
APPENDIX [U].

GUNS AND MOUNTS PHOTOGRAPHIC INDEX

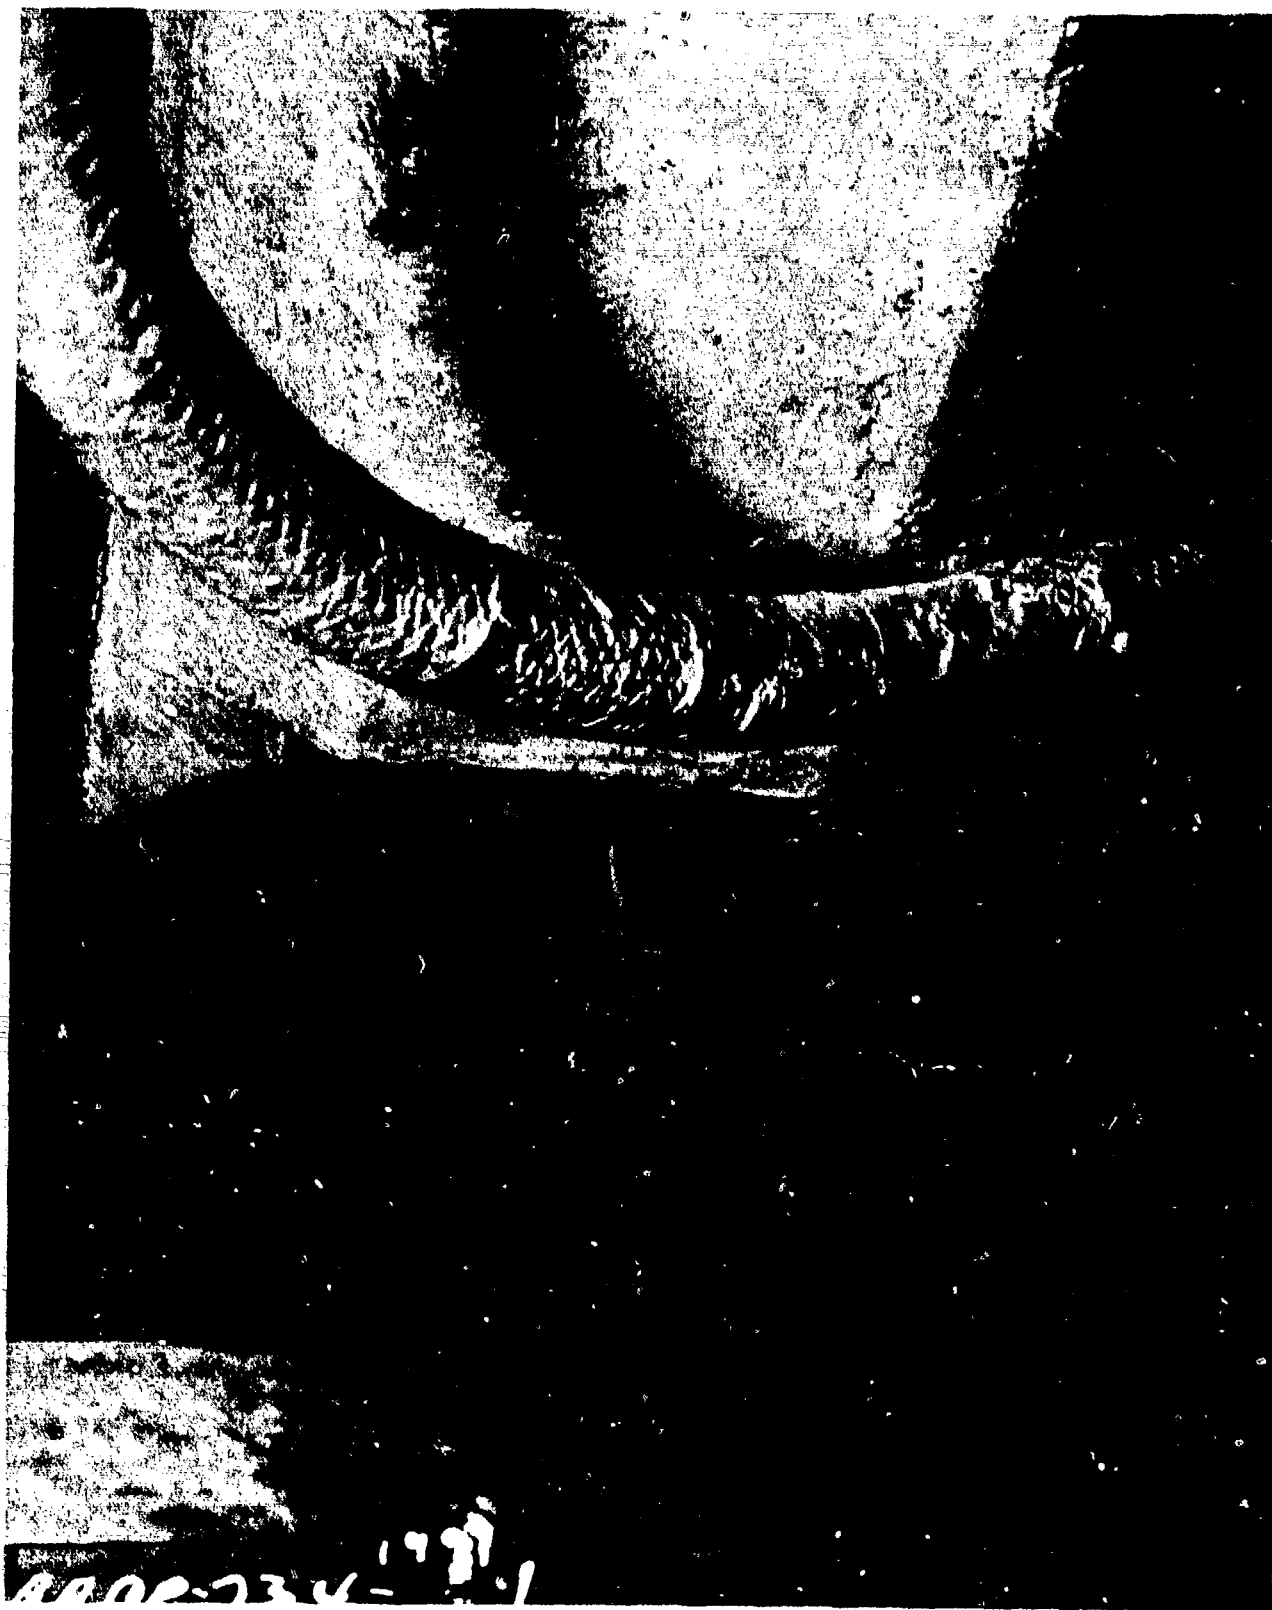
U.S.S. Albatross (9-35) - After Able
 Close up view of 12"/50 Cal., trunion
 block right gun forward end of the right
 gun of Turret No. 4 showing the broken section.
 Photo. No. Ka-Ch-234-1991-1.

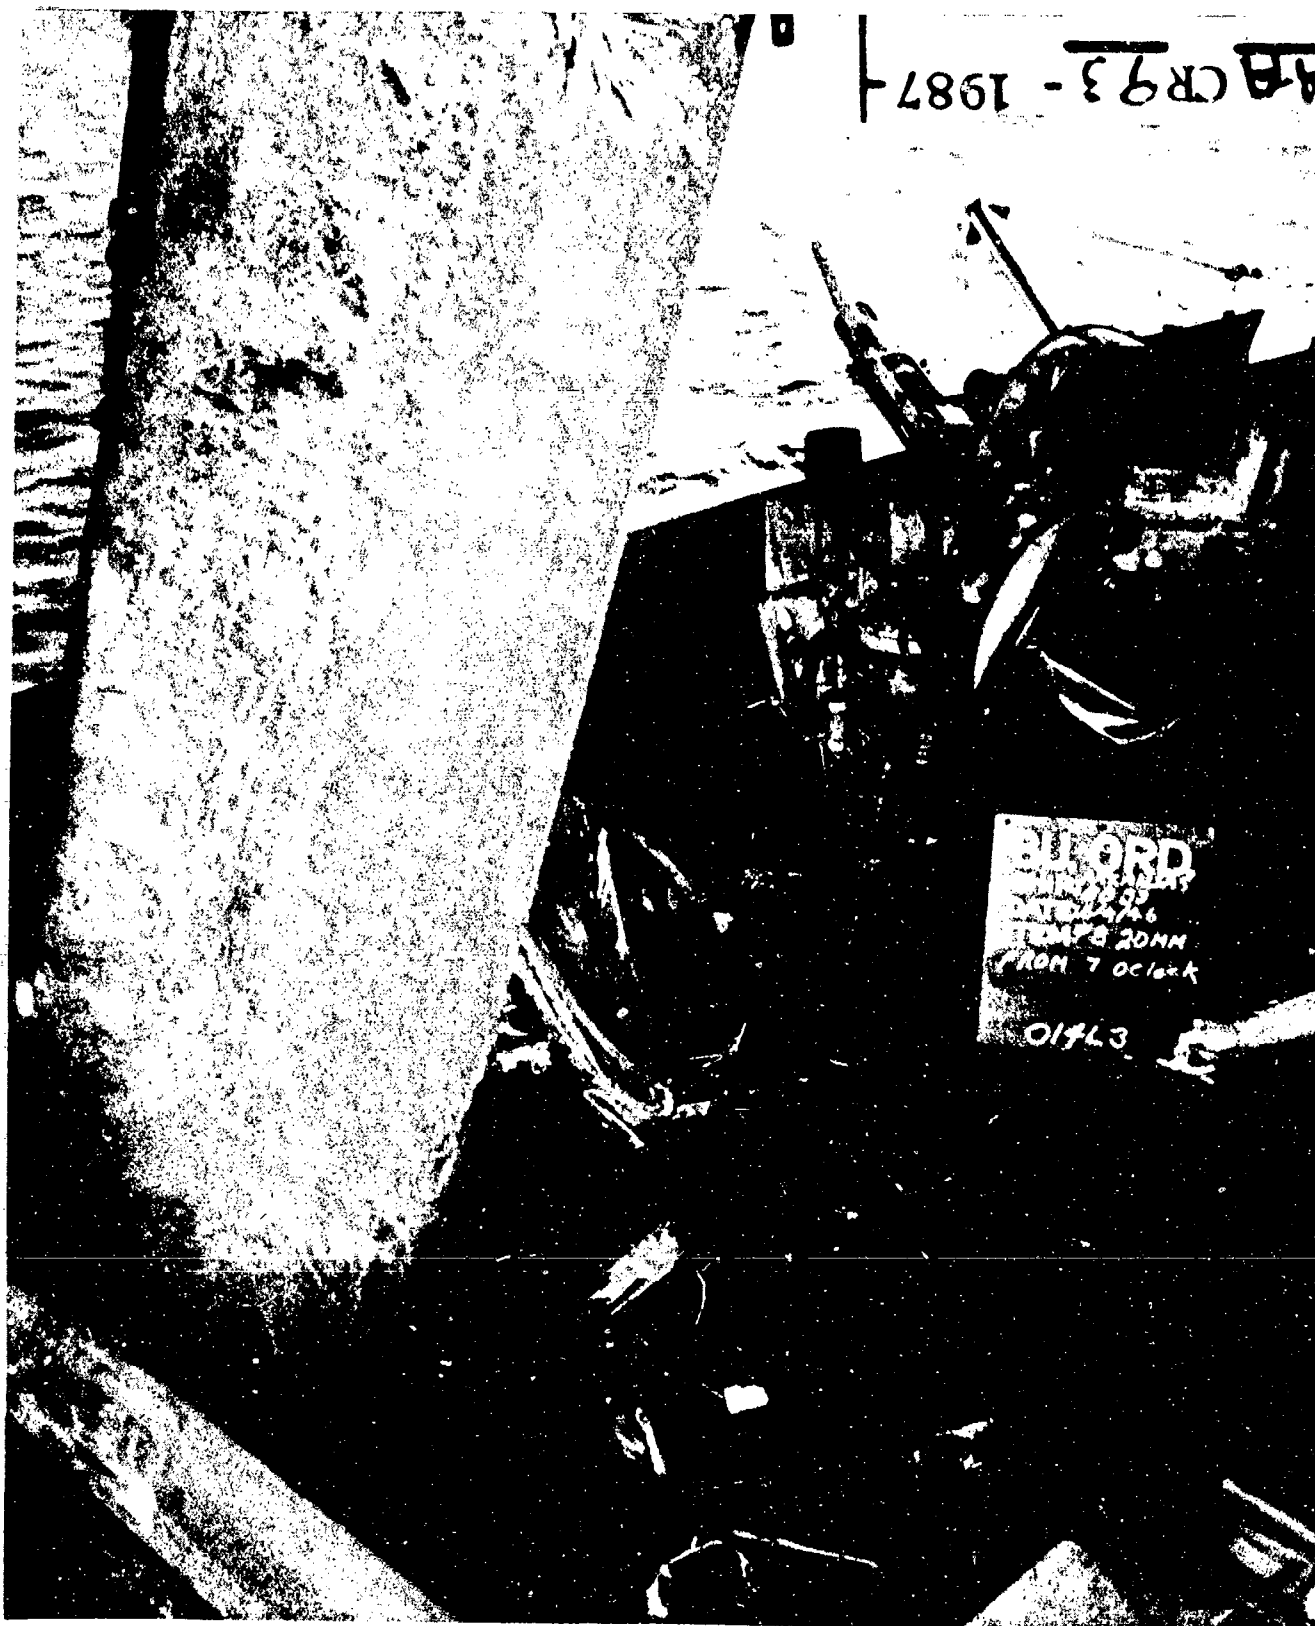
U.S.S. ARBANS (Ar-33) - After Action
Close up of 20 M. M. No. 8 showing
vent barrel and gun mechanism.
Photo. No. AA-CR-93-1987-12.

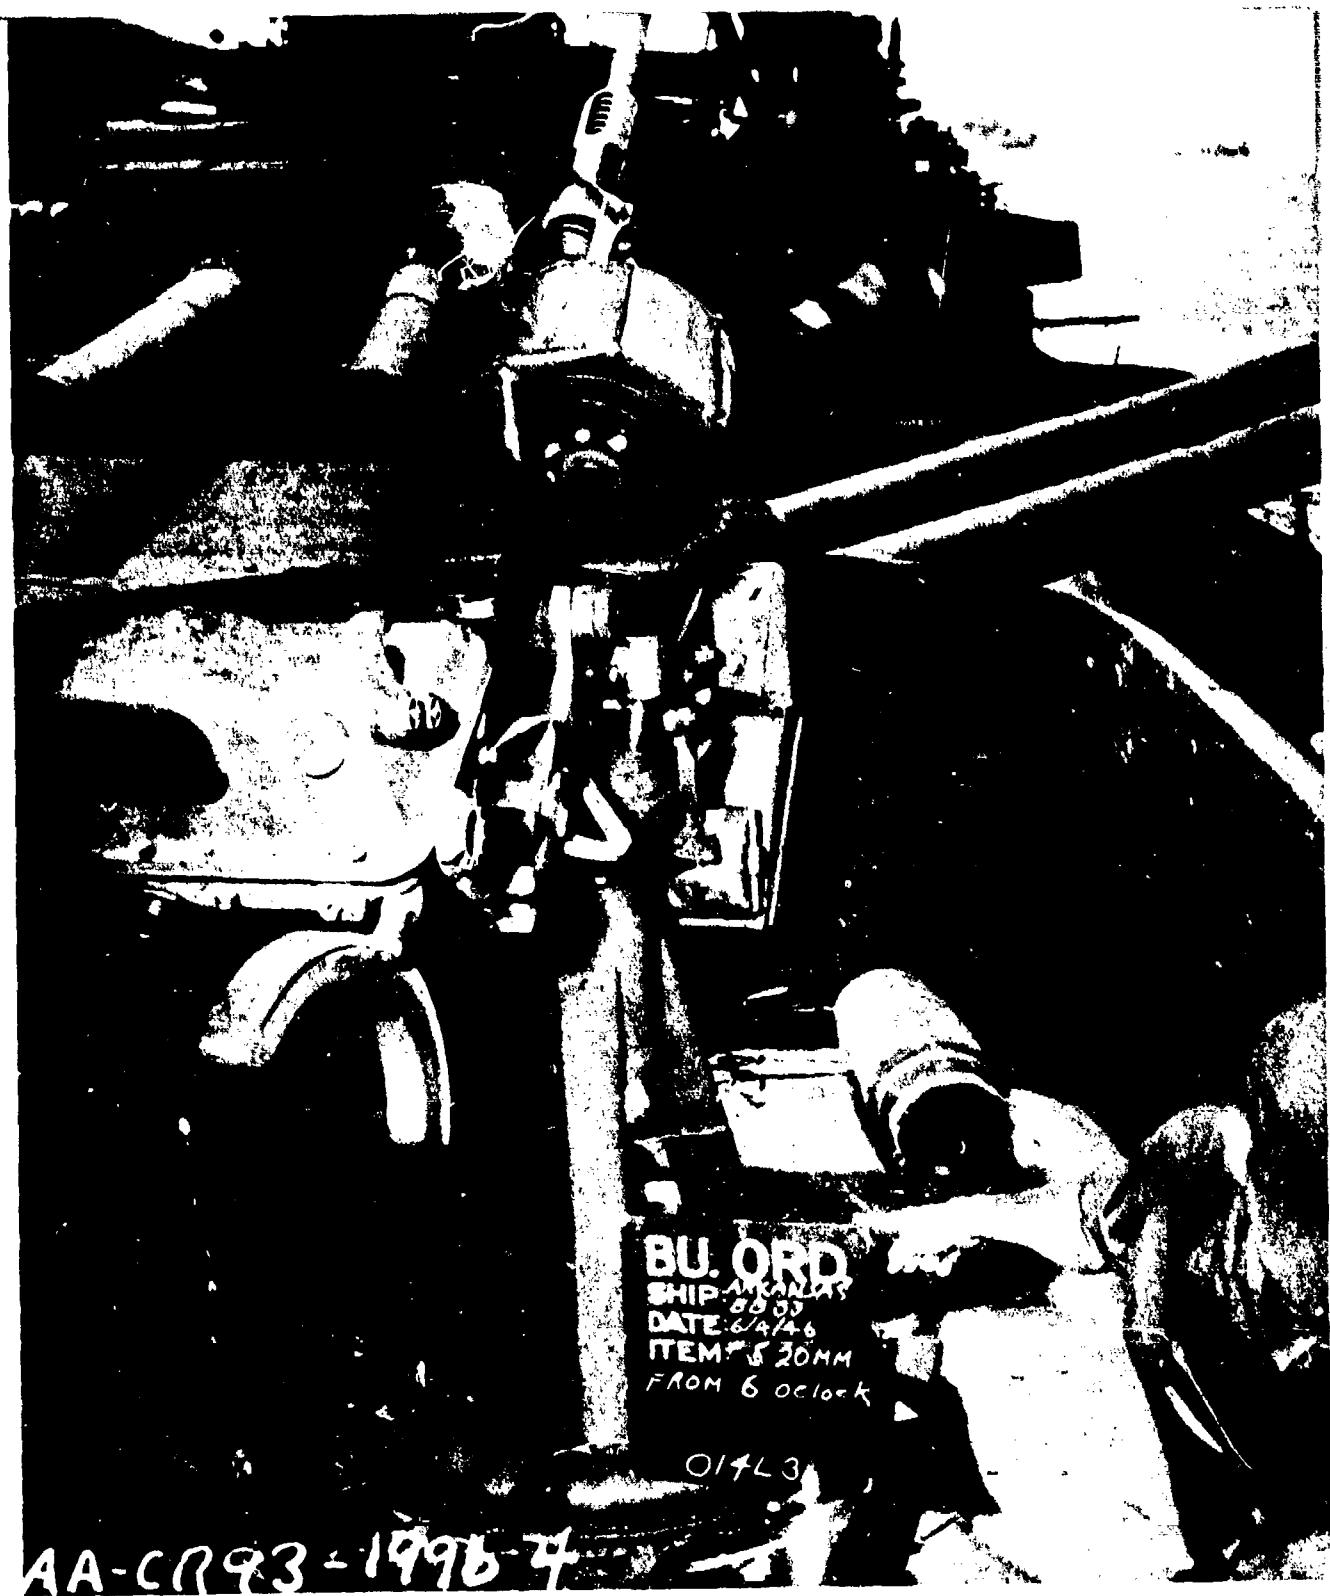
U.S.S. ARKANSAS (BB-33) - After Able
 Close up view of 20 MM Mt. No. 5, showing
 distorted magazine and empty case bag
 burned off.
 Photo. No. AA-CR-93-1996-4.

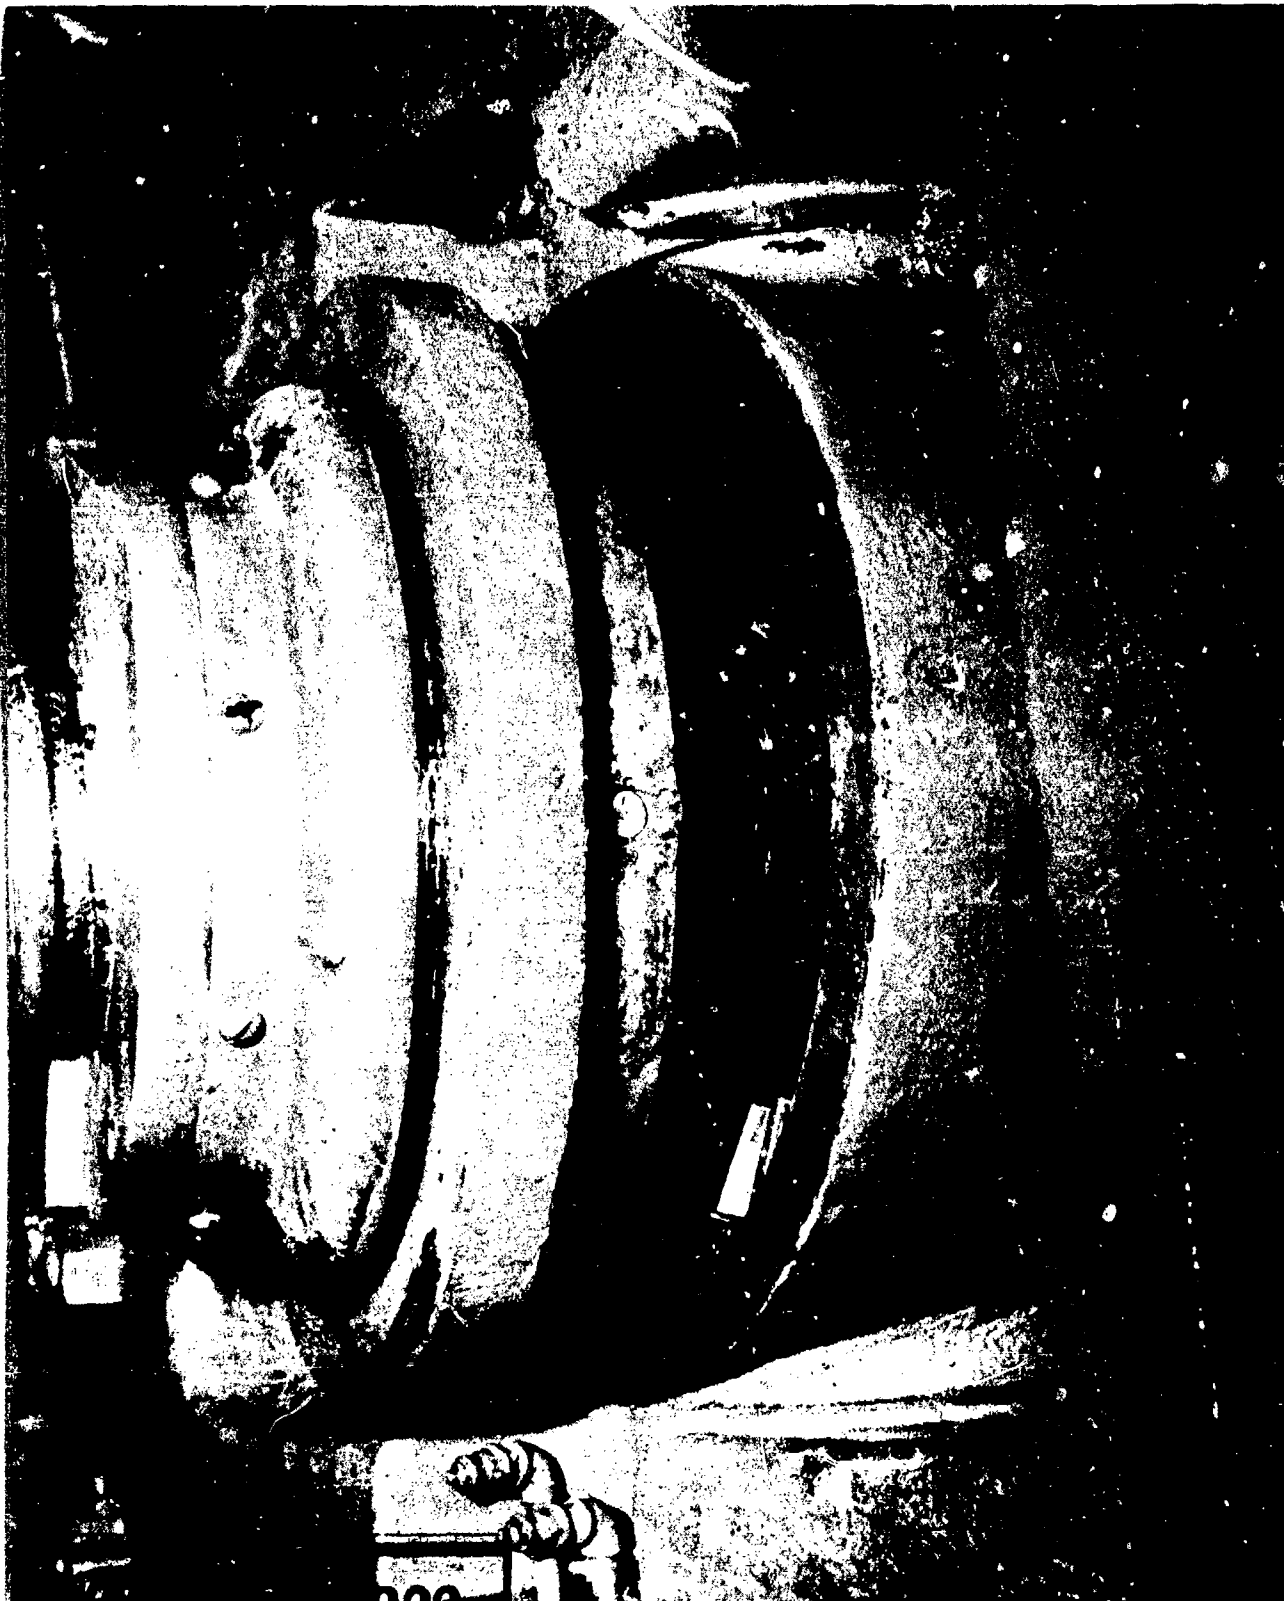
U.S.S. NEW YORK (BB-34) - After Baker
Close up view of left elevating screw in
14"/45 Cal., Turret No. 2. Showing
Elevating Screw Housing with upper Ball
Race in tact.
Photo No. AB-CR-83-4222-8

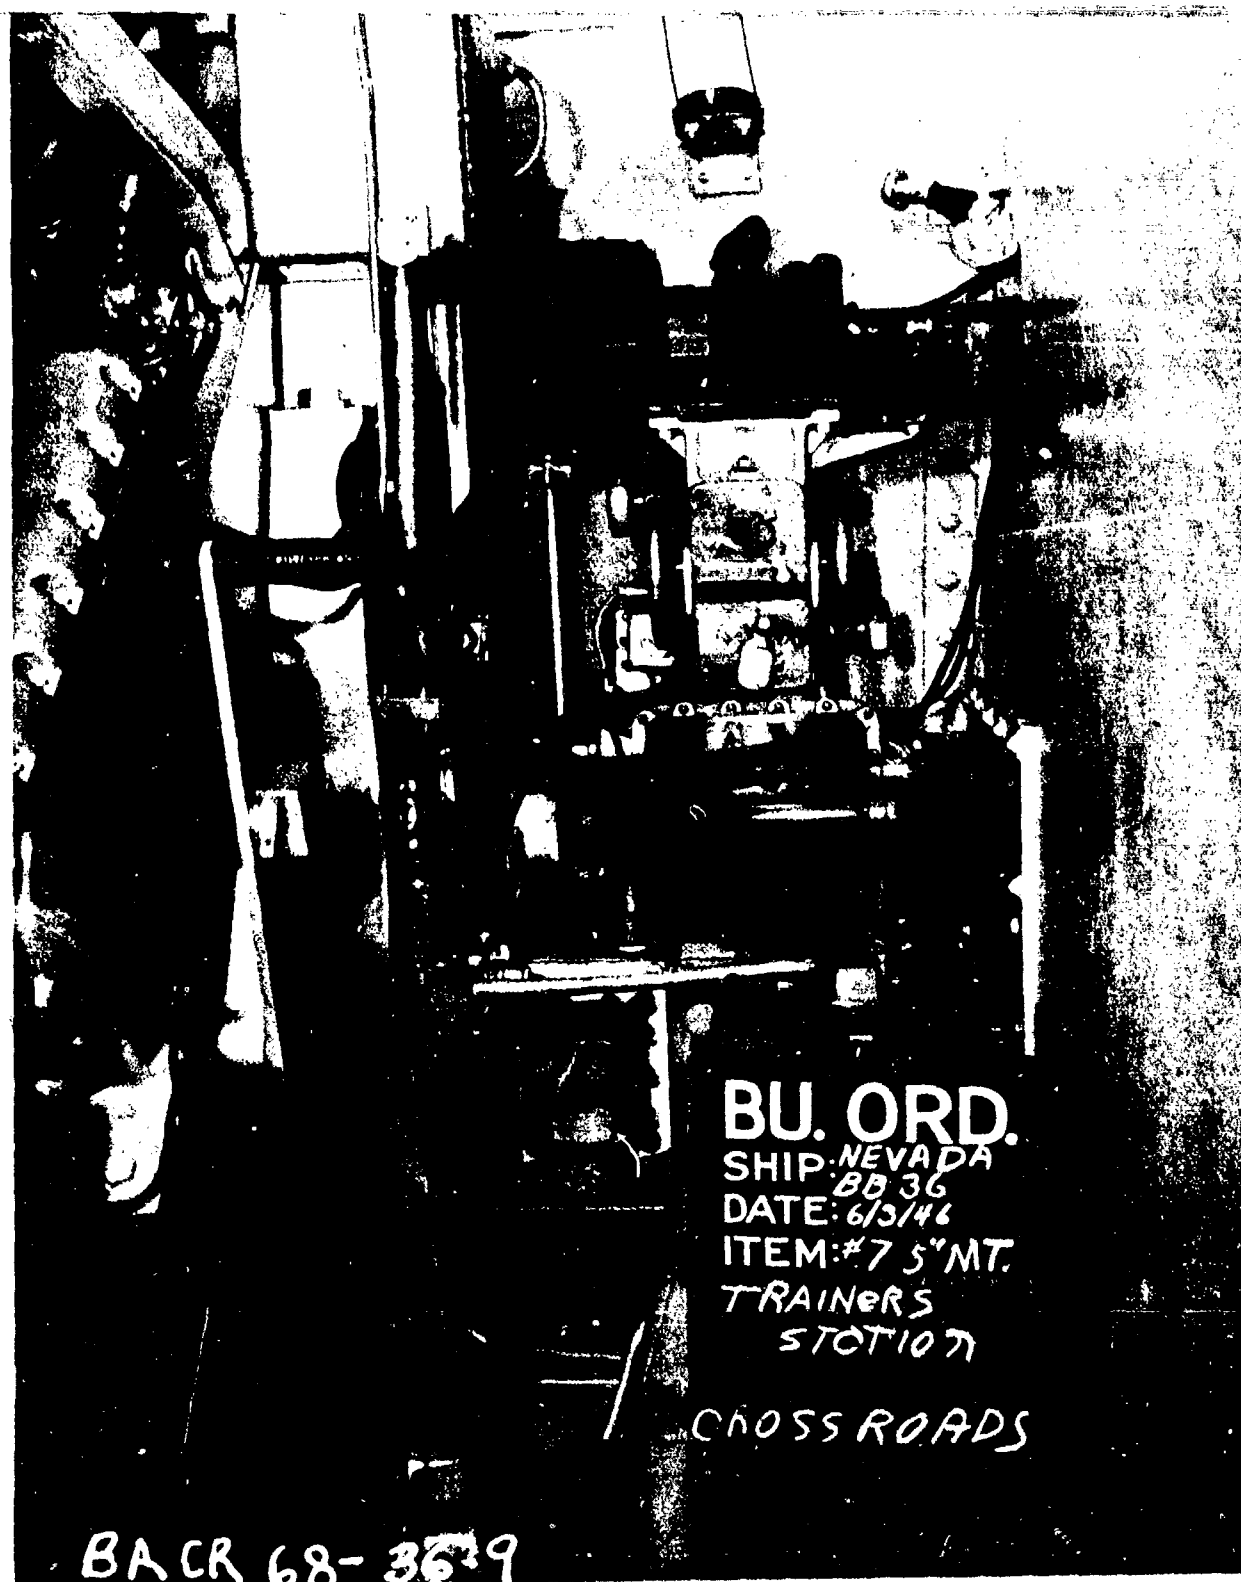
U.S.S. NEVADA (BB-36) - Before ALLE
View of 5"/38 Cal. twin mount No. 7
trainer's station showing condition
before Test "A".
Photo. No. BA-Ch-68-36-9.

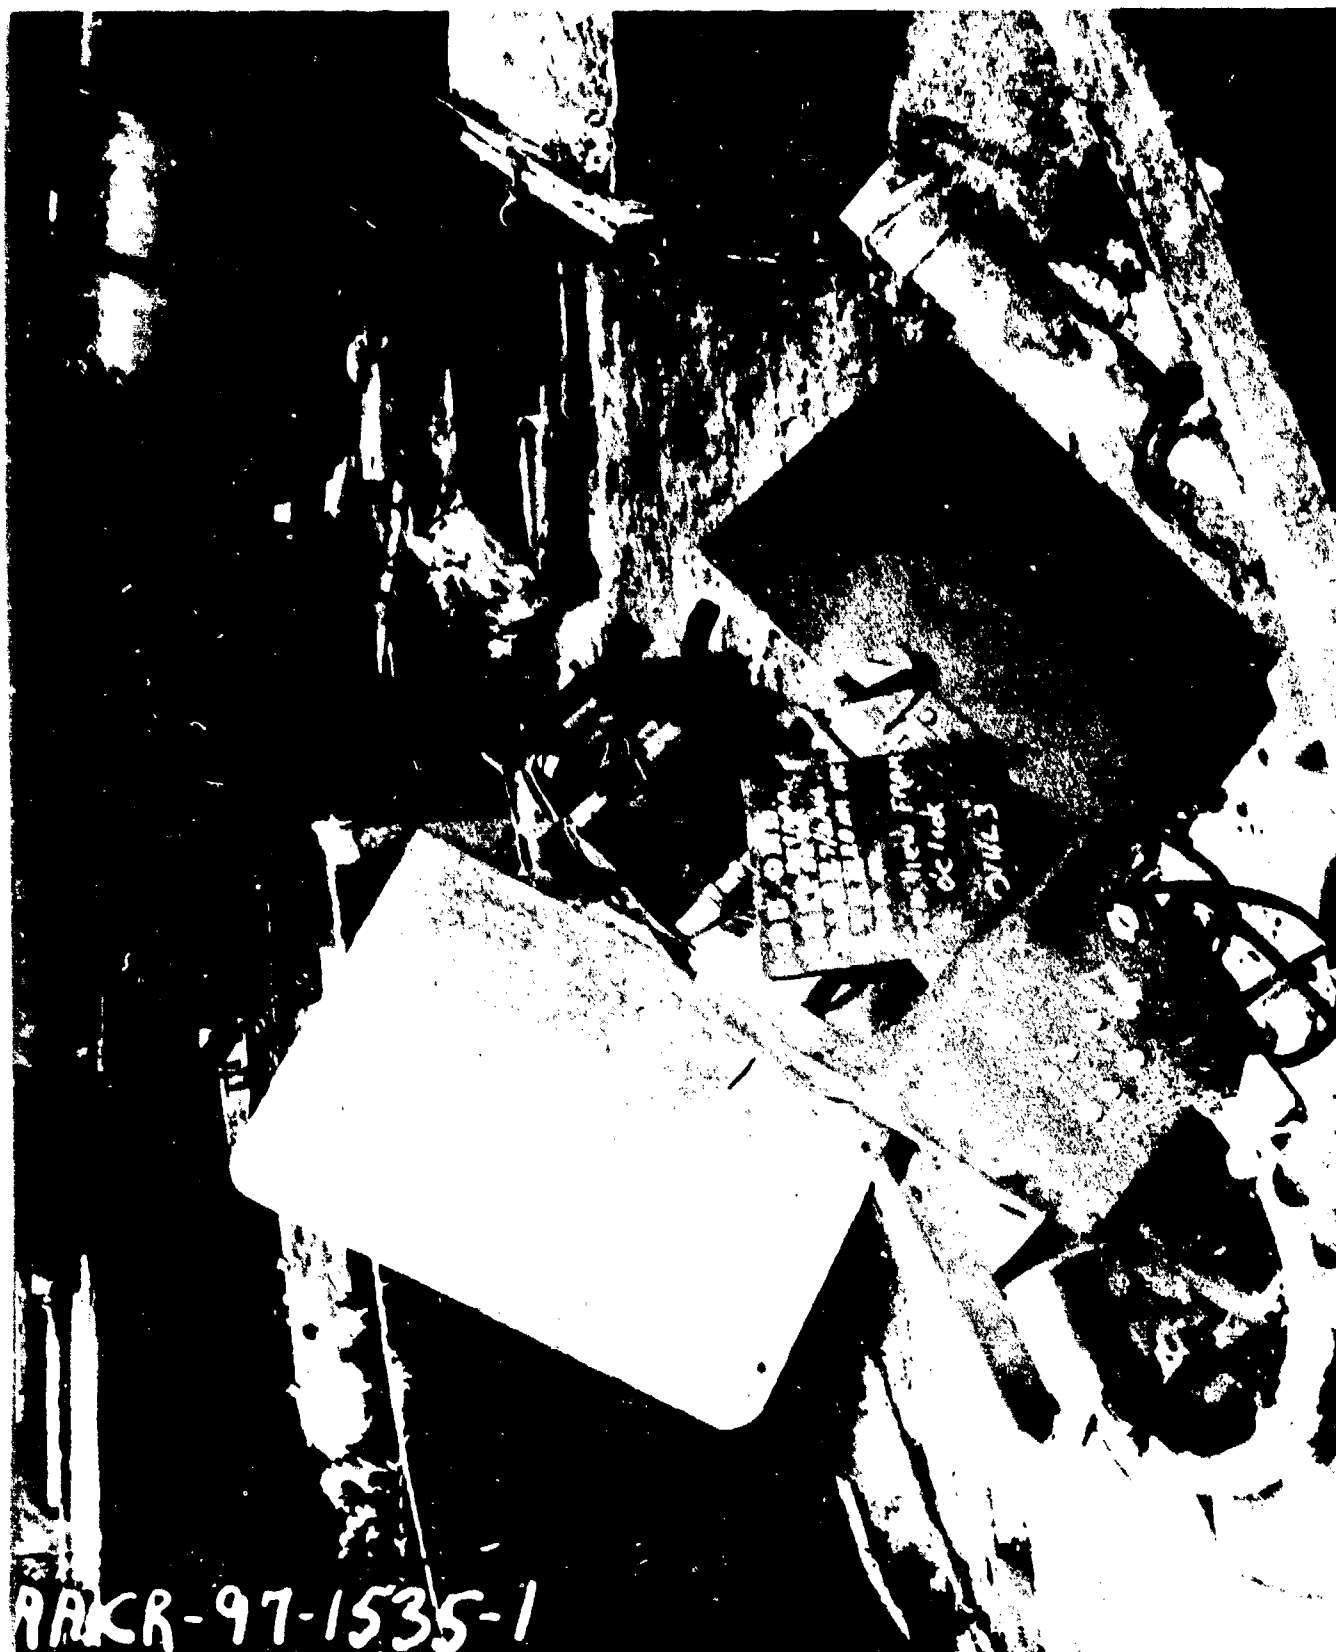
U.S.S. *Belmont* (DD-36) - After Action
 General view of 20 MM Twin Mt. No. 17
 showing the demolished target.
 Photo. No. AA-CR-97-1535-1.

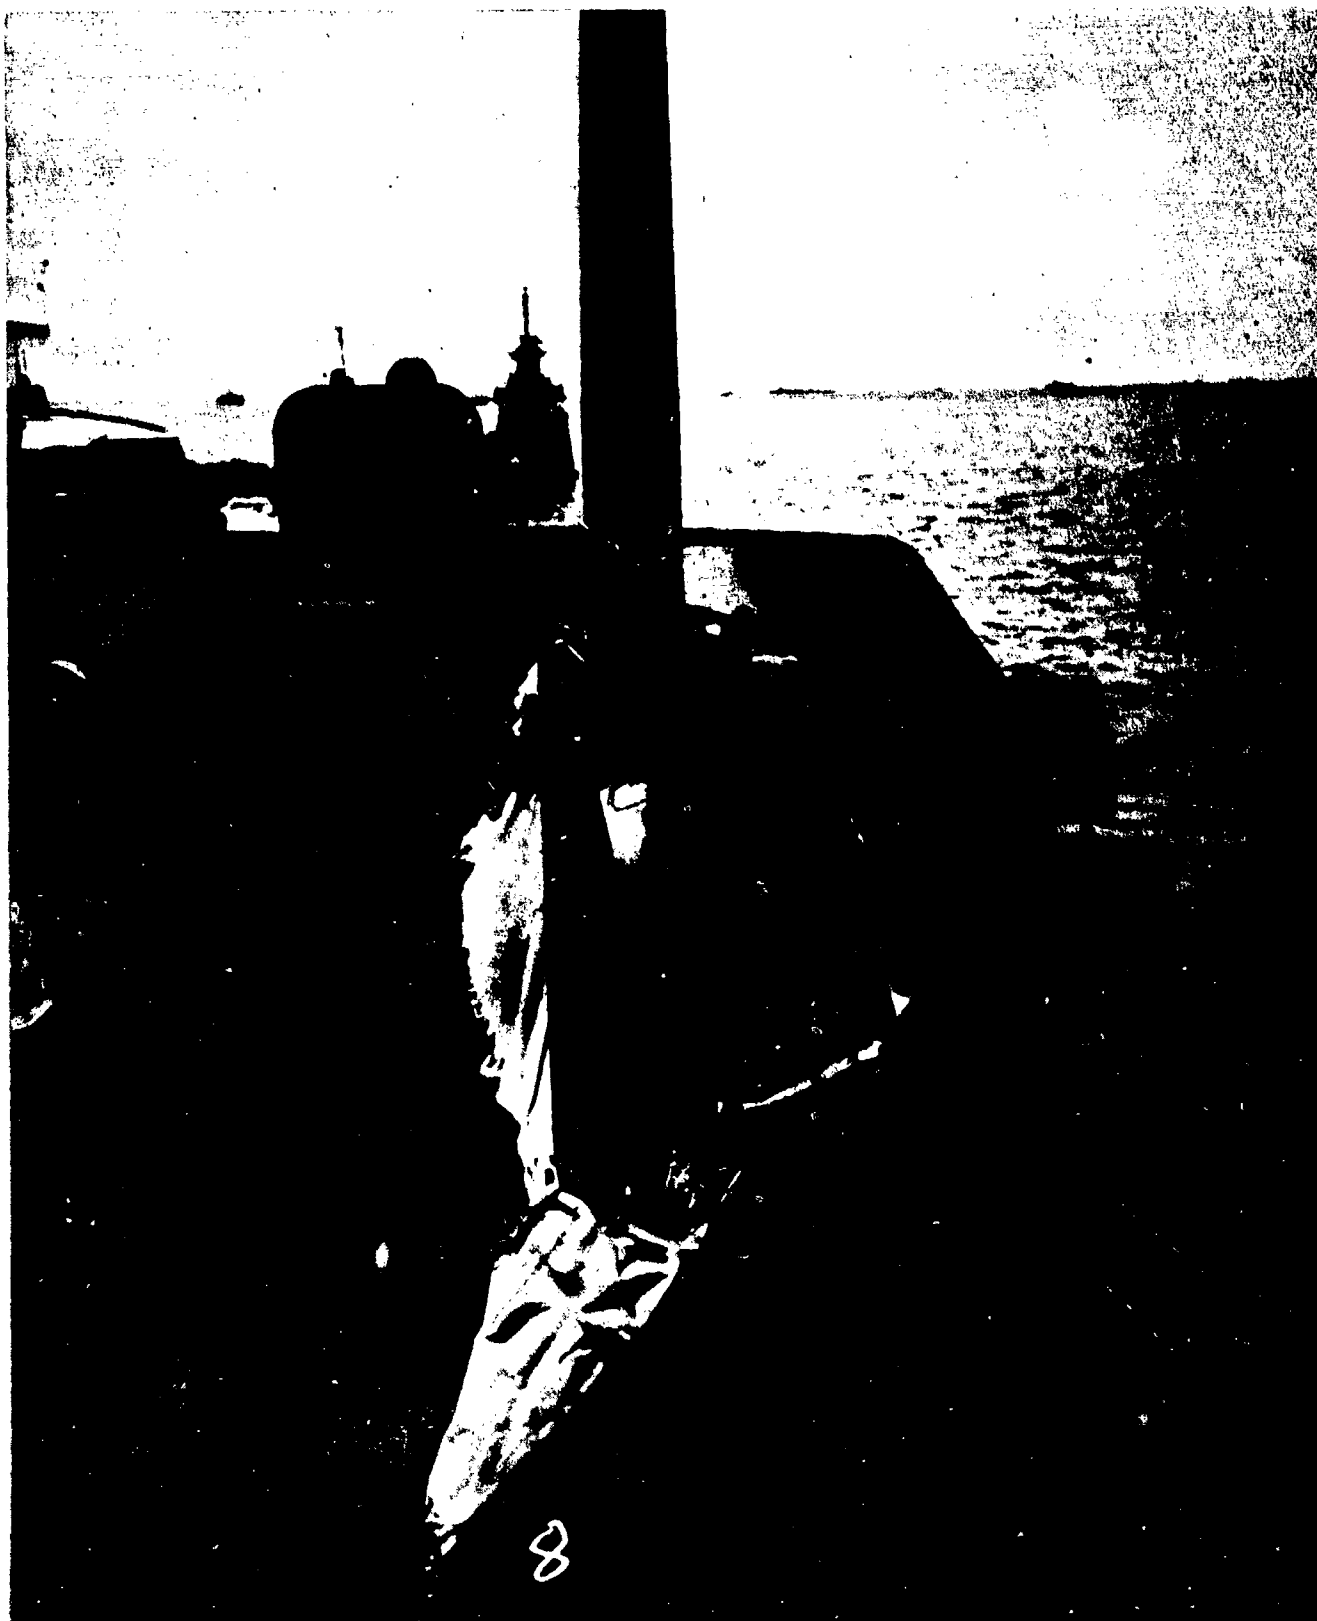
U.S.S. NEVADA (BB-36) - After Attack
Close up of damage to the Left Gun
Fort Buckler of 5"/38 Mt. No. 1.
Photo. No. AA-CH-9-1944-2.

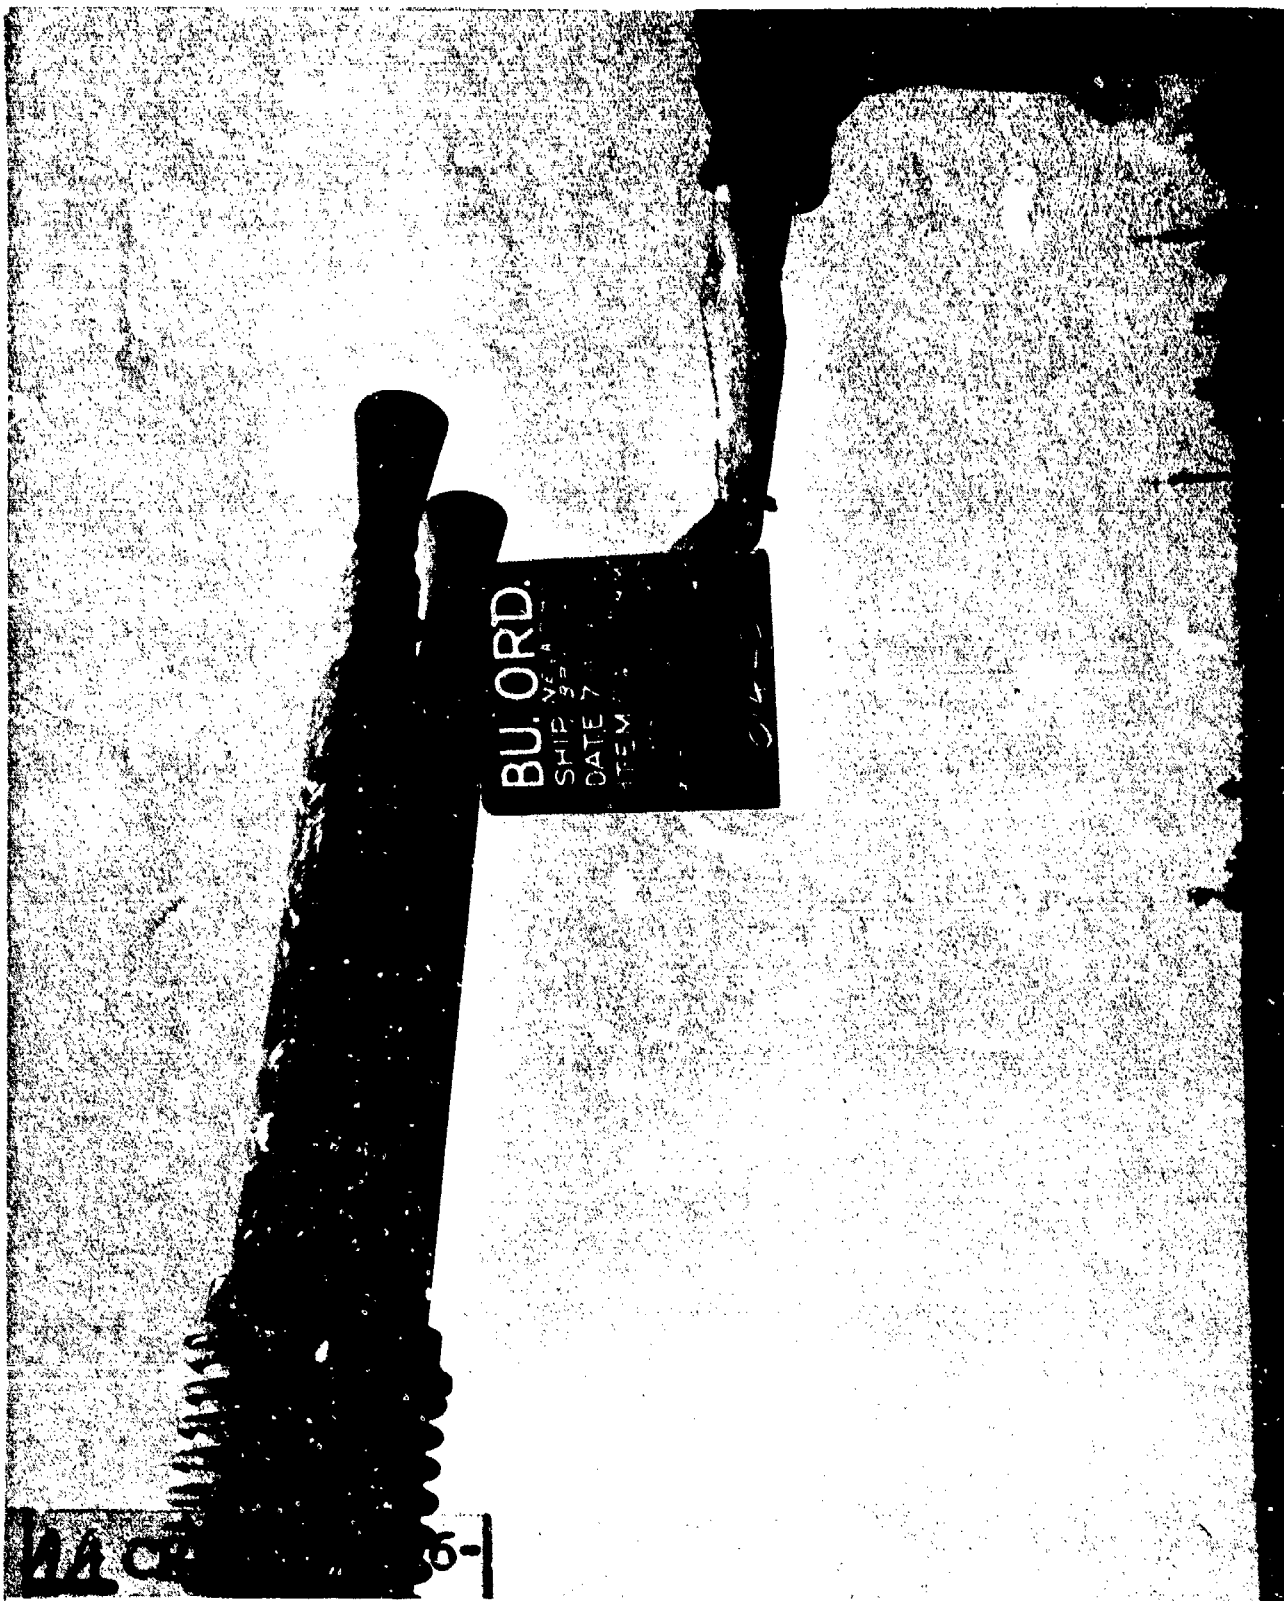
U.S.S. NEVADA (BB-36) - After Able
Close up view of the Right Gun Barrel
of 40 MM Twin No. 3. This design on
the barrel was caused by whipping action of
wire rope.
Photo. No. AA-CR-93-1996-12.

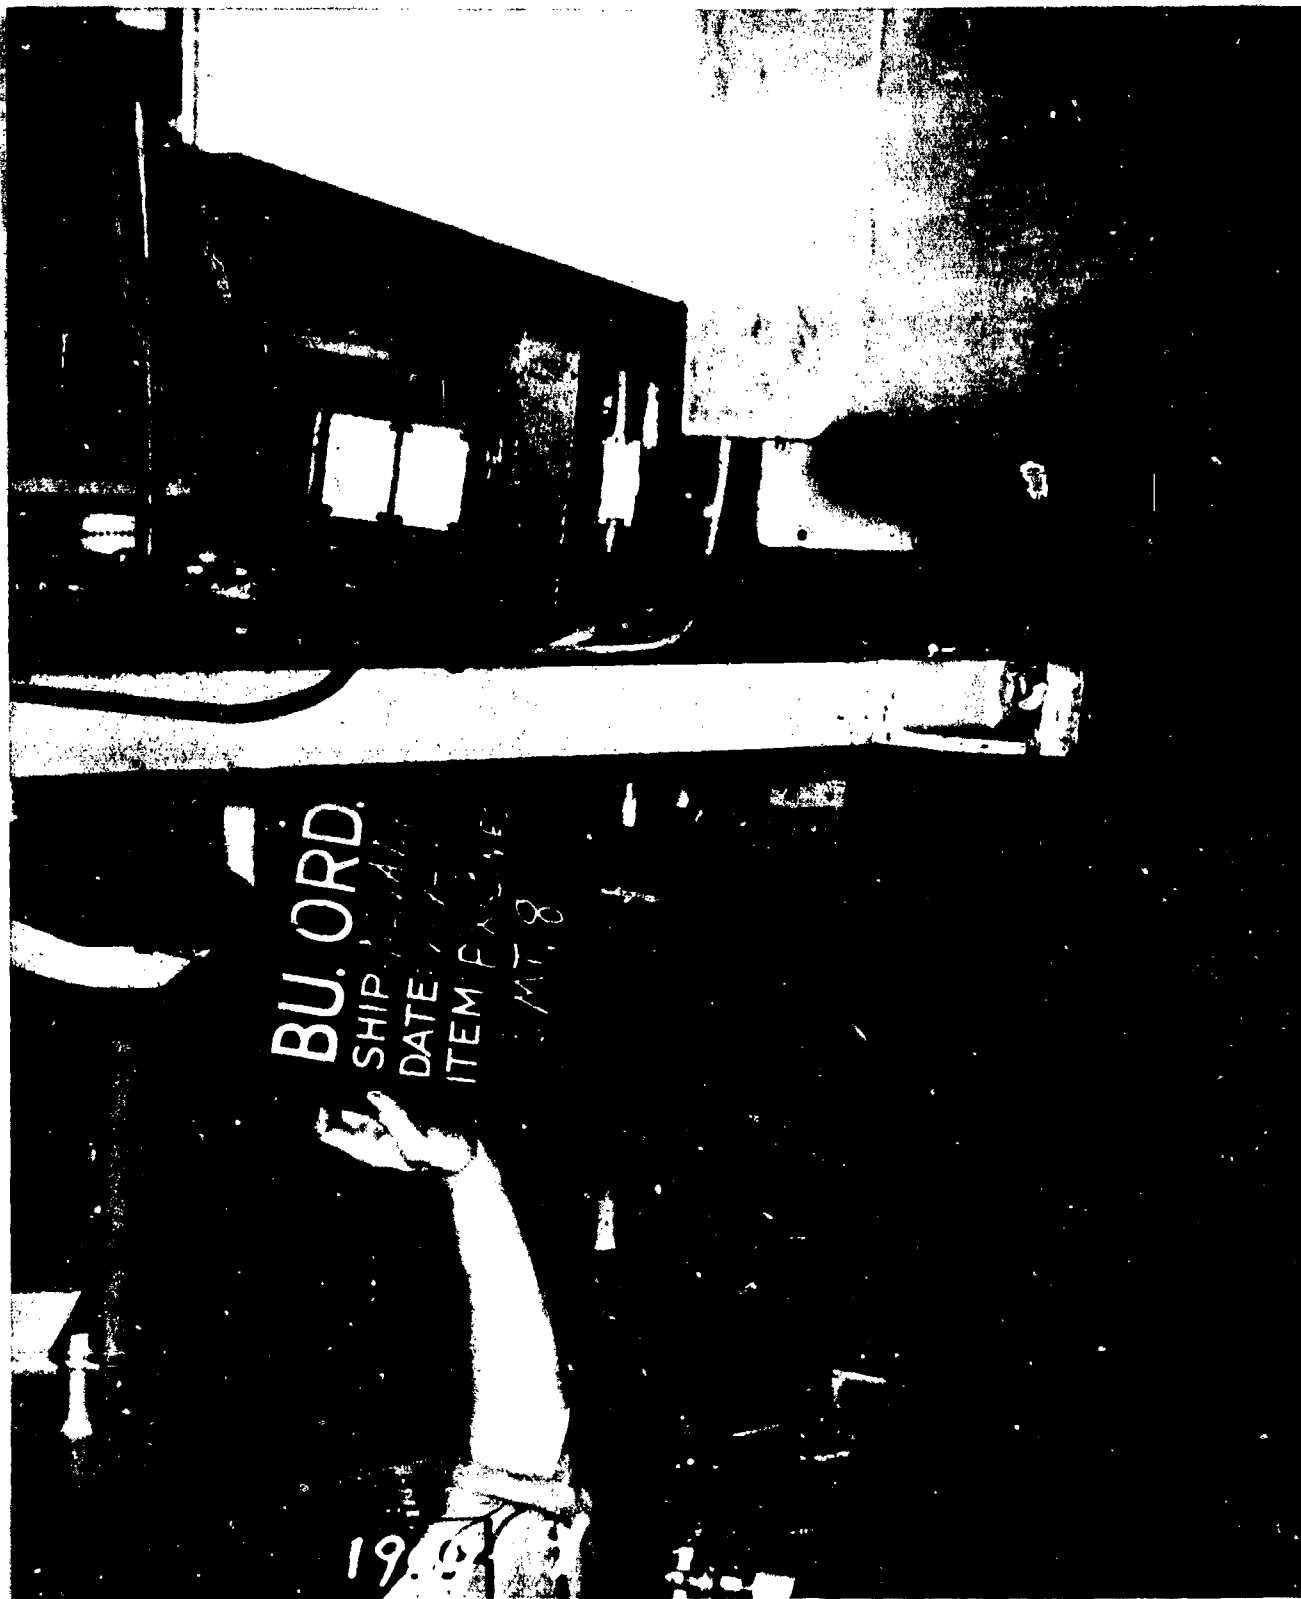
U.S.S. NEVADA (BB-36) - After Able
 Interior view of 5"/38 Lt. No. 8,
 showing the pinched oil lines at the
 trainer's station.
 Photo. No. AA-CR-93-1999-4.

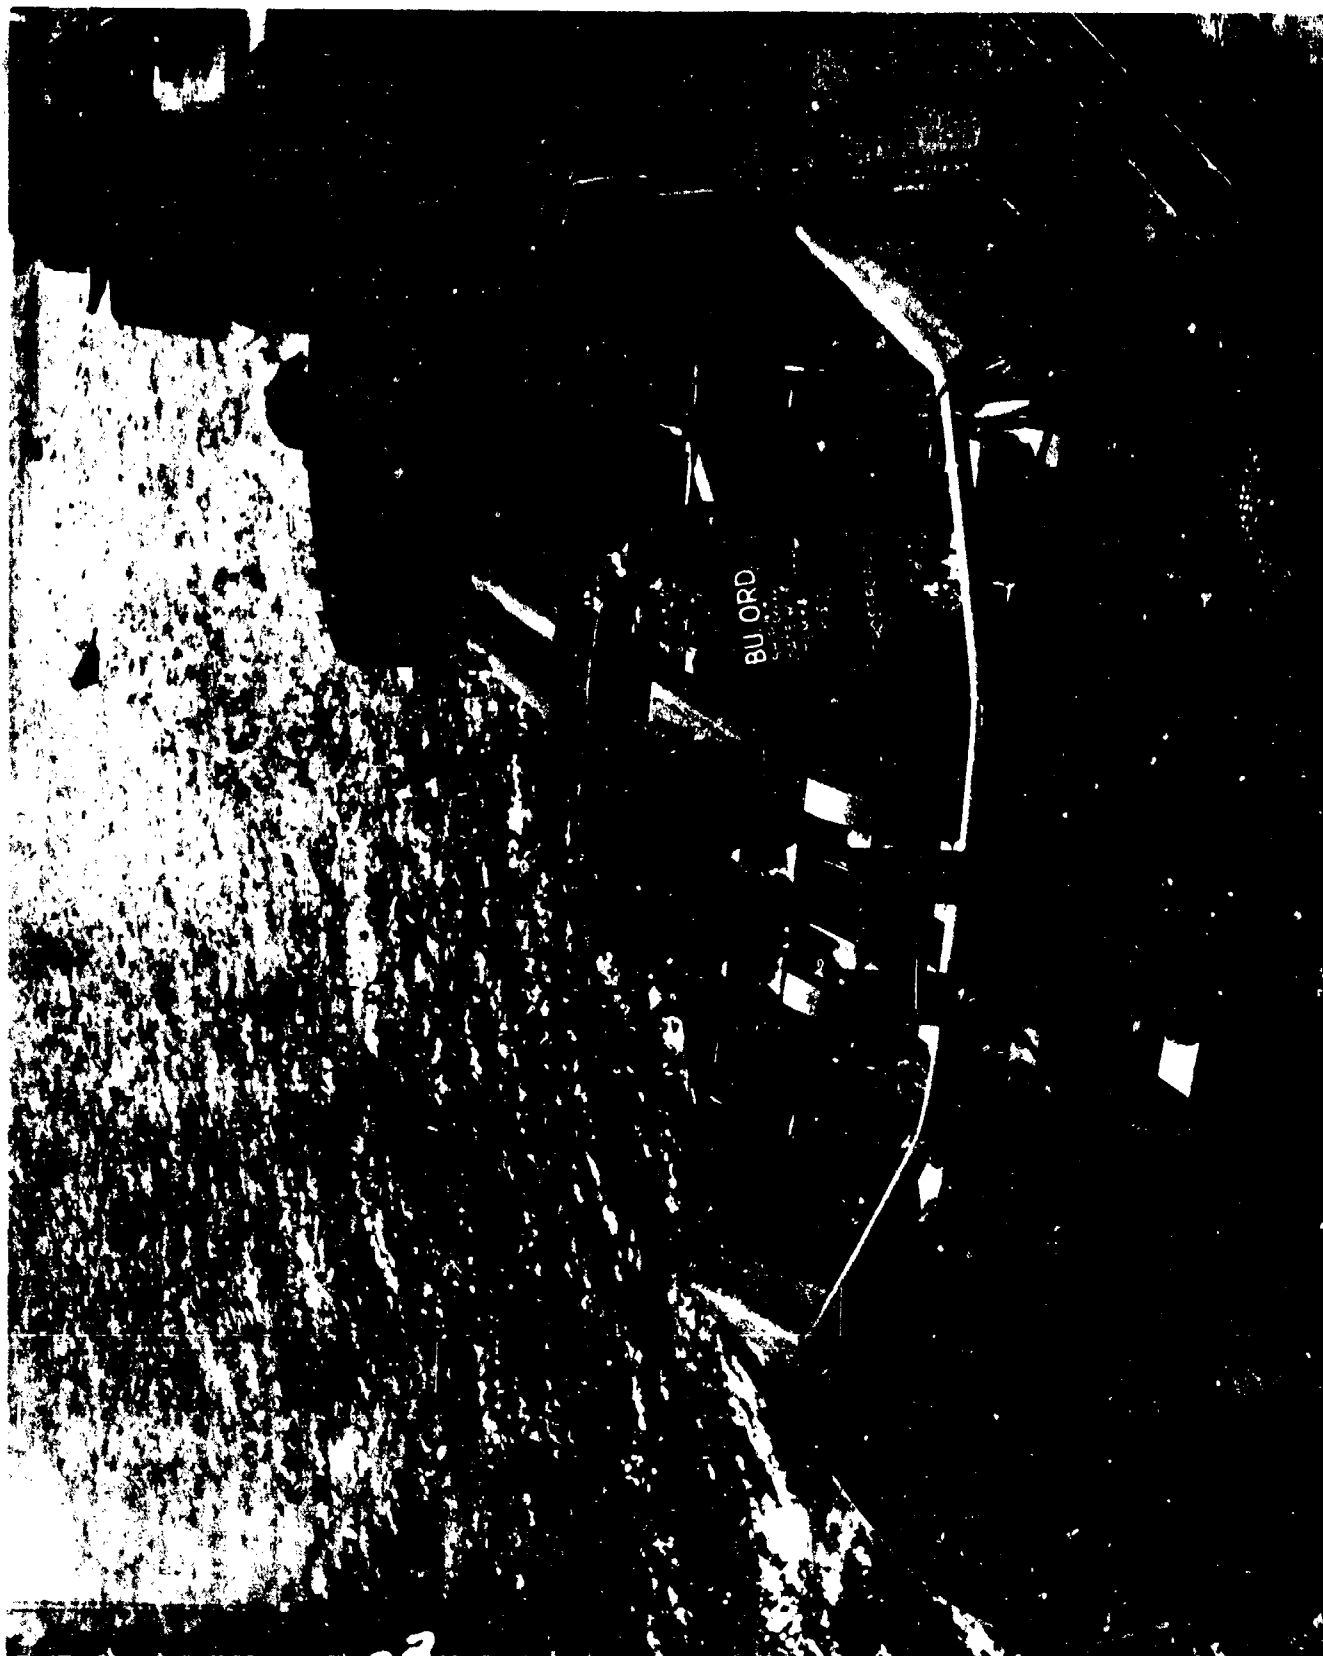
U.S.S. INDEPENDENCE (CVL-22) - Before Able
Condition of No. 4 40 MM Mount before Test "A".
Photo. No. BA-CR 97-313-3.
